**DEBRIS CONTROL AT HYDRAULIC
STRUCTURES IN SELECTED AREAS
OF THE USA AND EUROPE**

N. Wallerstein, C. R. Thorne

November 1996

Final Report

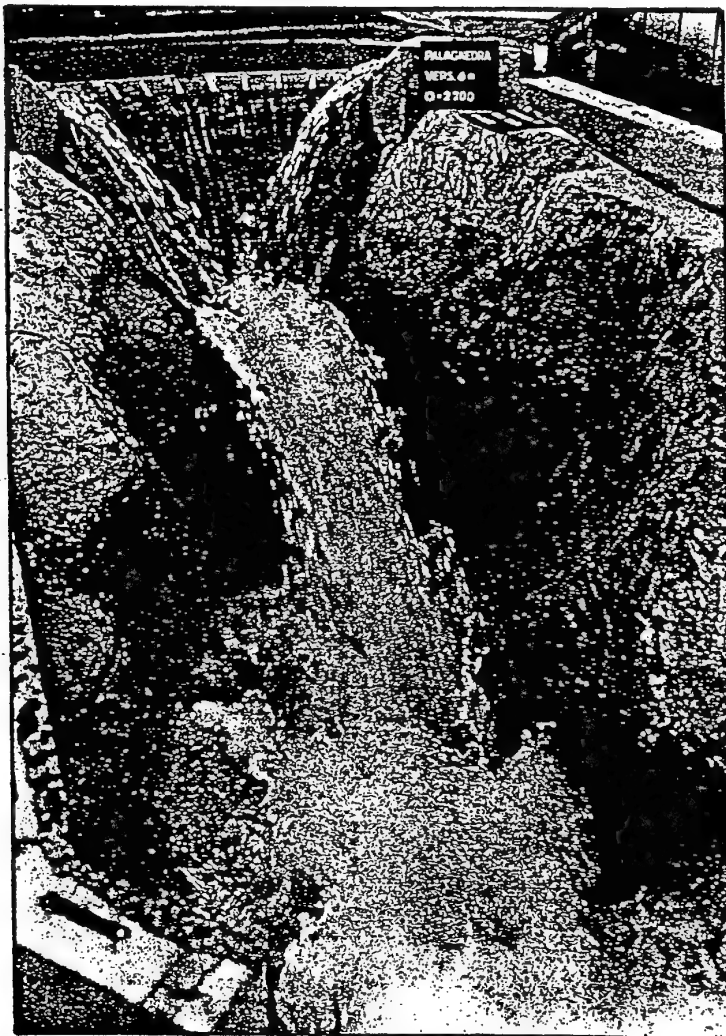
Plate 7 : Physical model (scaled 1:50) with remodelled spillway. Discharge 2.200 m³/s (after Vischer & Trucco, 1985).

- Raising the abutments by 4m to prevent overtopping.
- Removal of the dam top bridge and supporting piers to create a continuous weir crest.
- Raising and remodelling of the spillway guidewalls to ensure undisturbed passage of the increased discharge and debris load. Plate 7 shows the scale model with new spillway design.

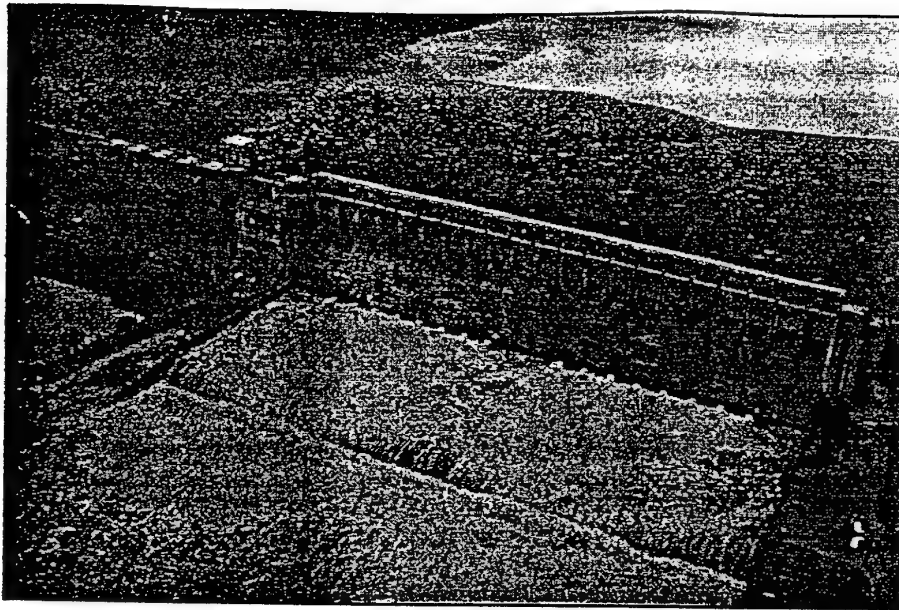
Bluestone Dam, March 1993, Flood Event

The larger debris accumulations span the whole width of the river valley and wedge against the dam face. A photograph of the March, 1993 flood event is presented in Appendix C. Approximately 16 hectares of drift and debris are observed prior to passage. In addition, a photograph illustrating the January, 1995 event demonstrates how the debris compacts against the dam face. Approximately 14 hectares of debris accumulated during the January flood.

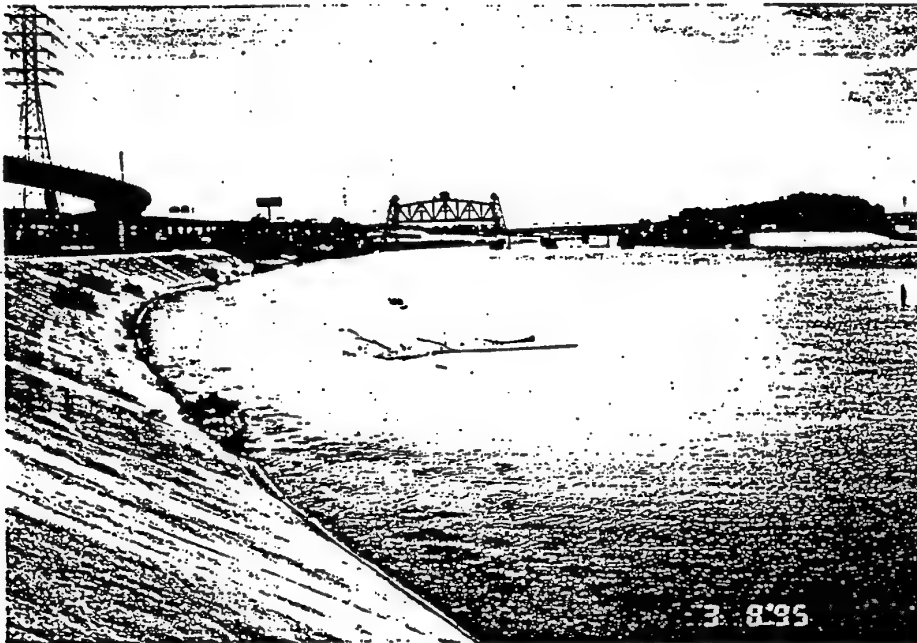
FIGURE B - MUD FLAT UPSTREAM OF MCALPINE WITH DEBRIS ACCUMULATION
(looking downstream toward canal)

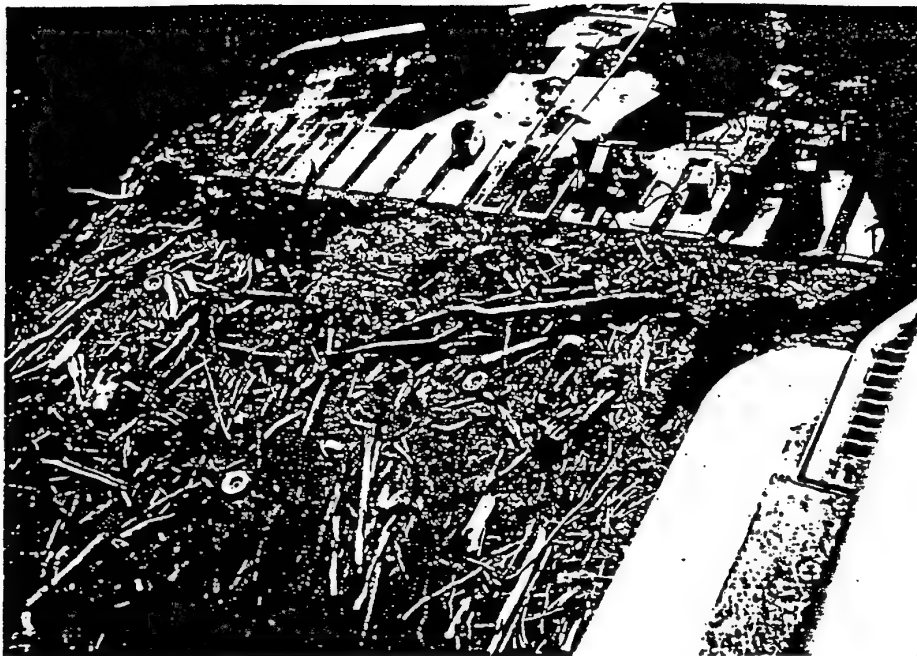
FIGURE C - DEBRIS ACCUMULATION - MARKLAND 600-FT LOCK CHAMBER
(looking down into the lock)

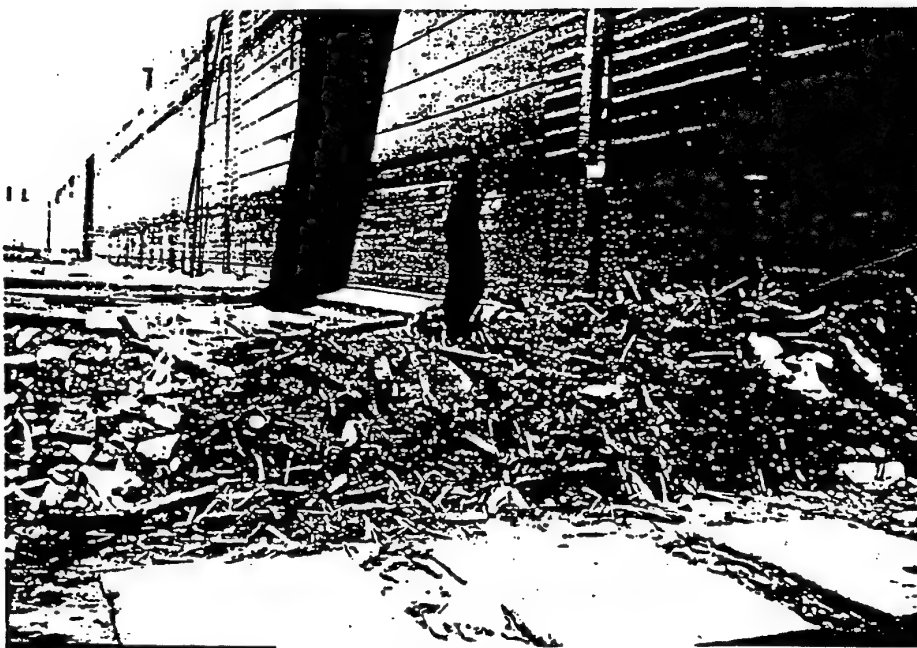
FIGURE D - DEBRIS ACCUMULATION - MARKLAND 600-FT LOCK CHAMBER
(view from down in the lock chamber)

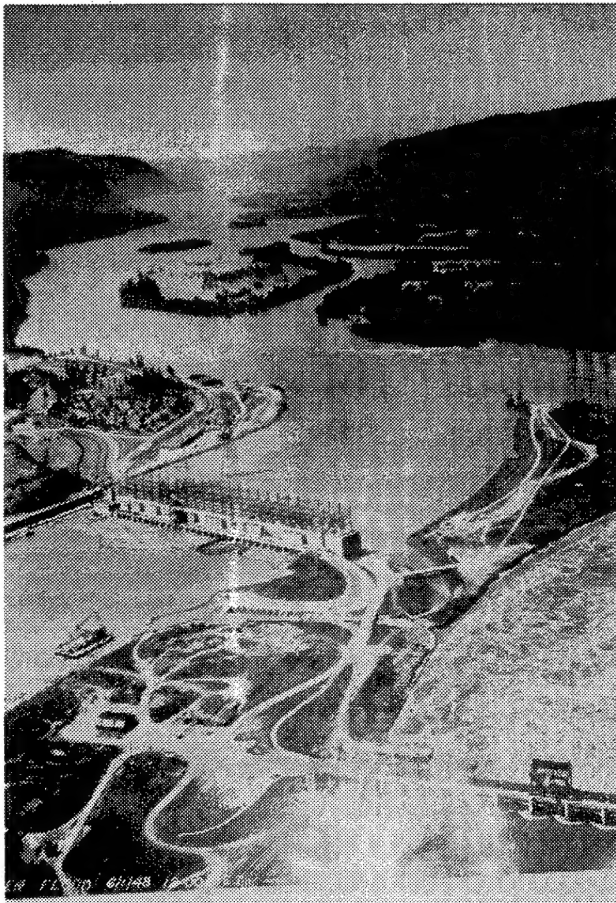
Bonneville Powerhouse No. 1 with debris jam in 1948
